Property and Timber Pest Report

Inspection Date: 27 Jun 2023

Property Address: Sample Sample 0123

Company Name: West Coast Inspections

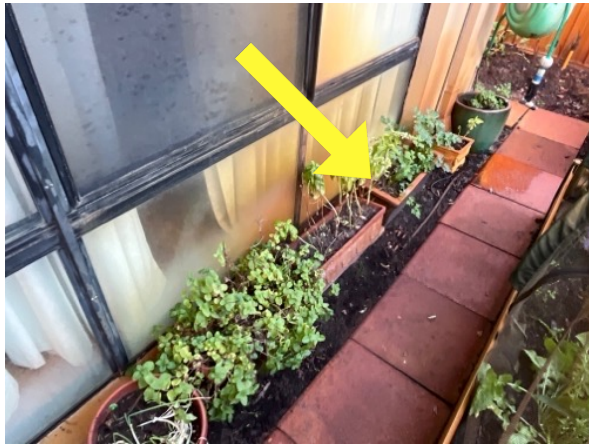
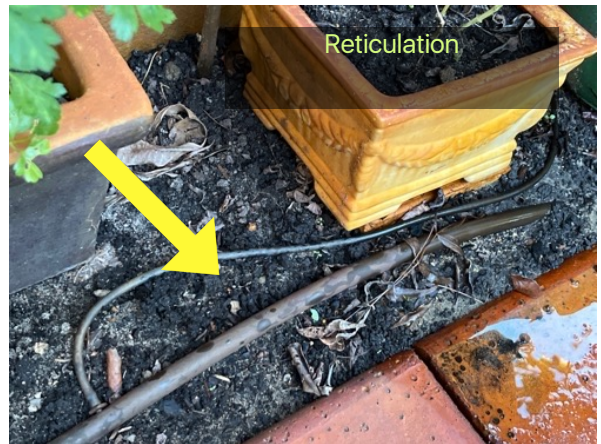
Conditions conducive to timber pest attack 2.01

Garden beds were found directly in contact with the building walls. The garden beds can include untreated timber, and with a combination of moisture from watering hosing can make conditions conducive to termite activity and concealed termite ingress.

It is highly advised to clear these areas to make visual inspections possible. Alternatively the application of a chemical barrier need to be implemented immediately.

Consultation with a licensed pest control technician about the cost and installation of such a barrier is highly advised.

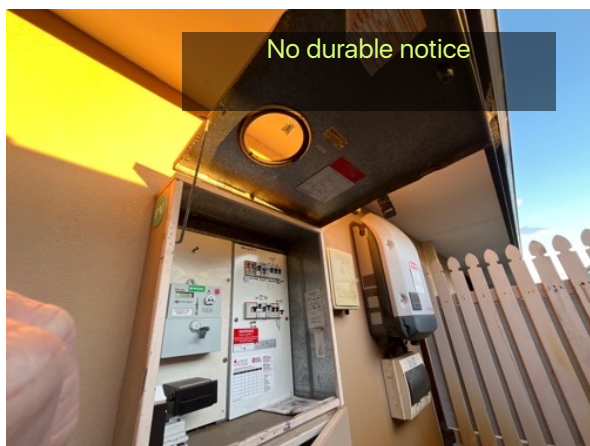
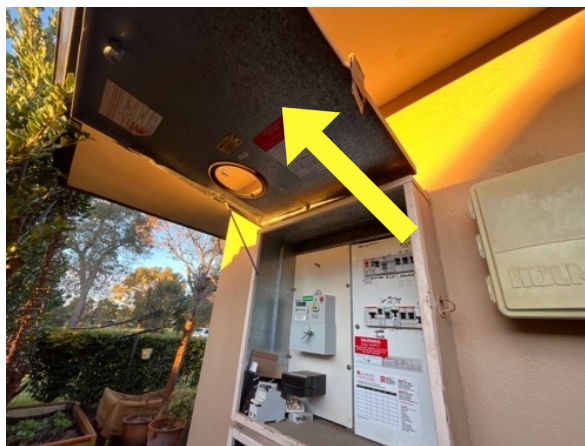
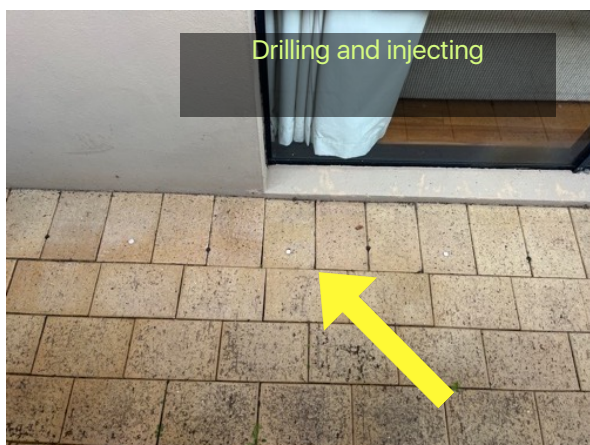
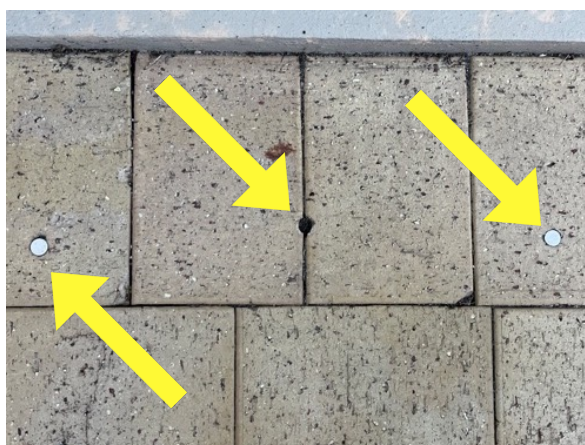
There is no information in the form of a durable notice to indicate the date and type of chemical used for the barrier. The warranty associated with these barriers are usually subject to annual inspections.

If a current termite management system can not be confirmed and it is highly recommended to consult a licensed pest technician to install a system immediately.
