# Property and Timber Pest Report

Inspection Date: 27 Nov 2023

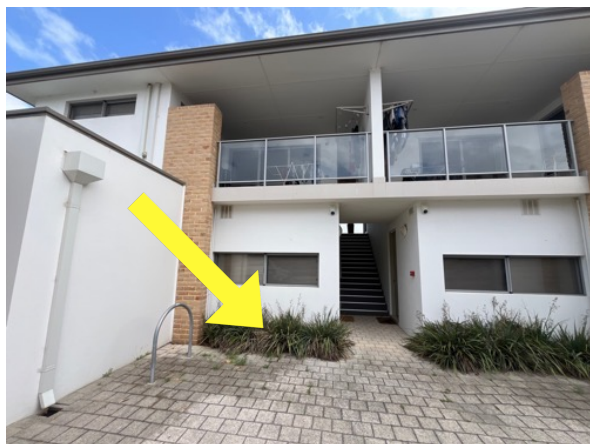
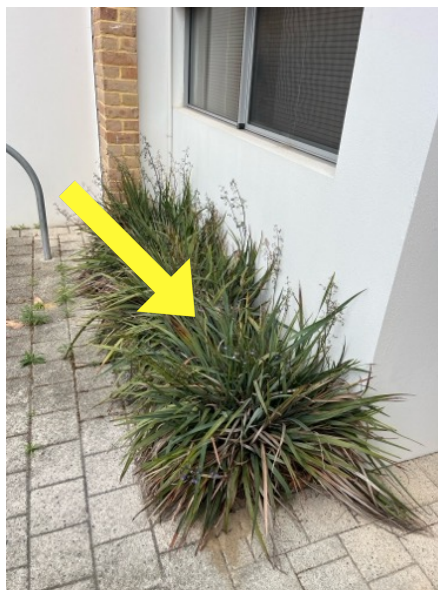
Garden beds were found directly in contact with the building walls. The garden beds can include untreated timber, and with a combination of moisture from watering hosing can make conditions conducive to termite activity and concealed termite ingress.

It is highly advised to clear these areas to make visual inspections possible. Alternatively the application of a chemical barrier need to be implemented immediately.

Consultation with a licensed pest control technician about the cost and installation of such a barrier is highly advised.
