Property and Timber Pest Report

Inspection Date: 27 Jun 2023

Property Address: Sample Sample 0123

Company Name: West Coast Inspections

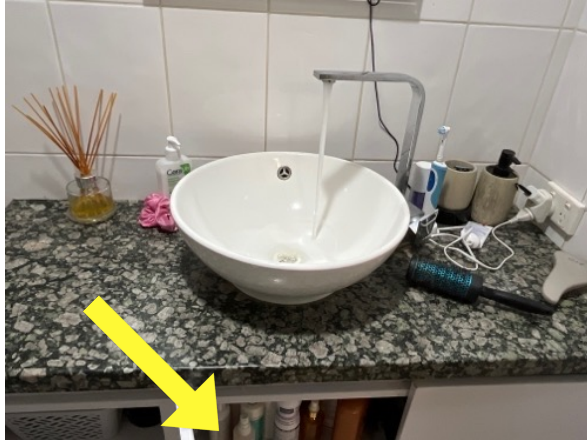
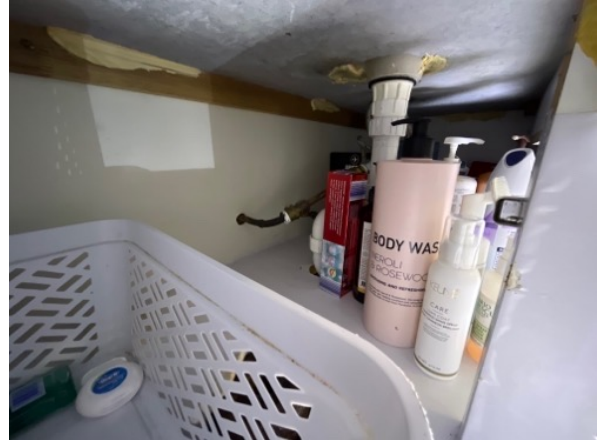
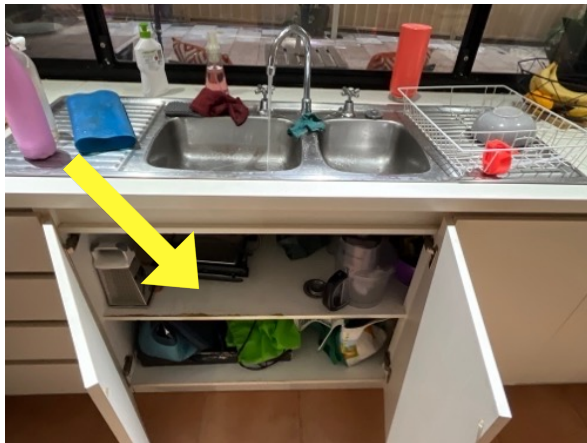
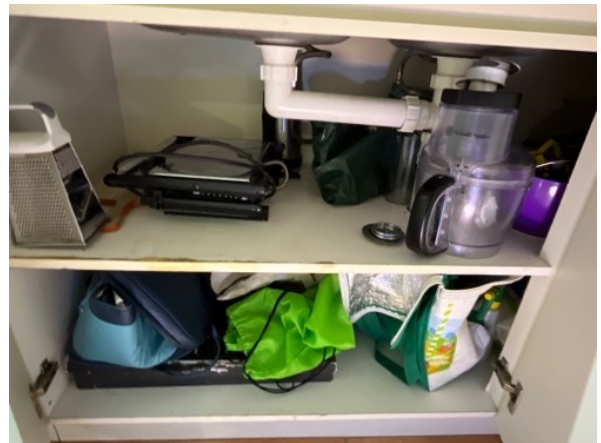
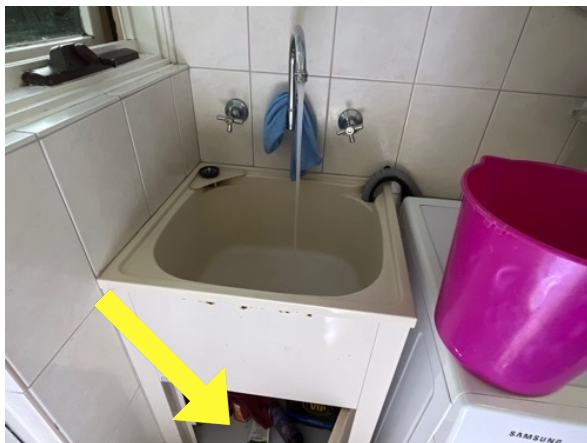
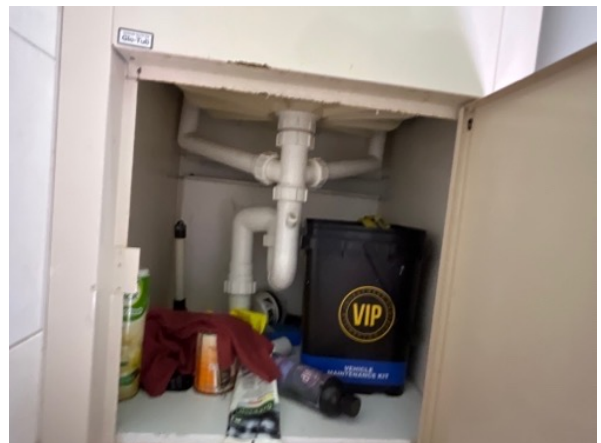
For your information 1.04

Location: All Internal Areas

Finding: Additional Photos - Internal areas inspected

These photographs are an indication of the areas inspected. Some photographs may point out obstructions and limitations which impeded full inspection of the property at the time of inspection. Some photographs may also point out minor cosmetic maintenance items which are normally excluded from a structural inspection. Always contact your building inspector should you have any questions.

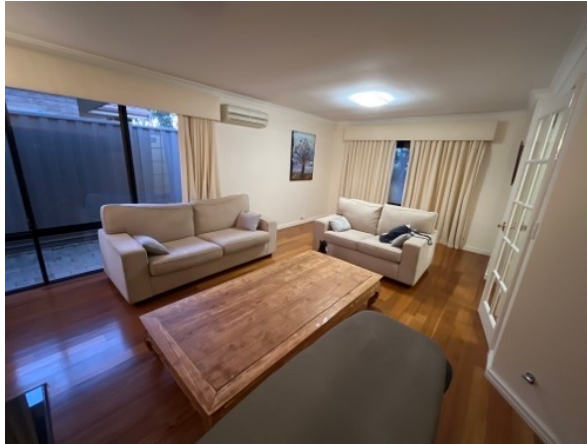
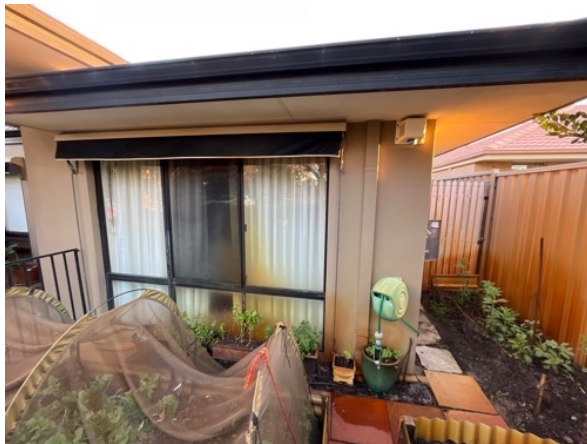
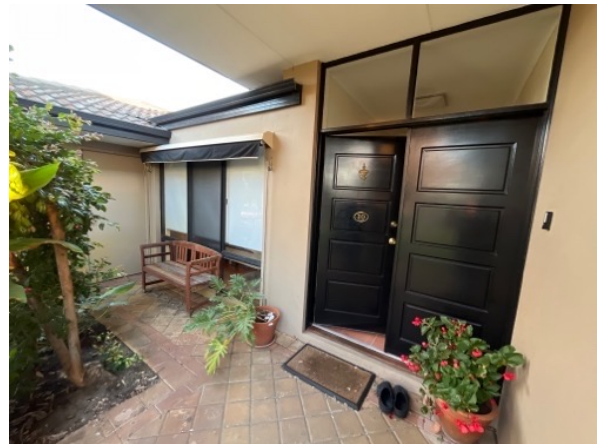
For your information 1.05

Location: All External Areas

Finding: Additional Photos - External areas inspected

These photographs are an indication of the areas inspected. Some photographs may point out obstructions and limitations which impeded full inspection of the property at the time of inspection. Some photographs may also point out minor cosmetic maintenance items which are normally excluded from a structural inspection. Always contact your building inspector should you have any questions.
