# Property and Timber Pest Report

Inspection Date: 27 Nov 2023

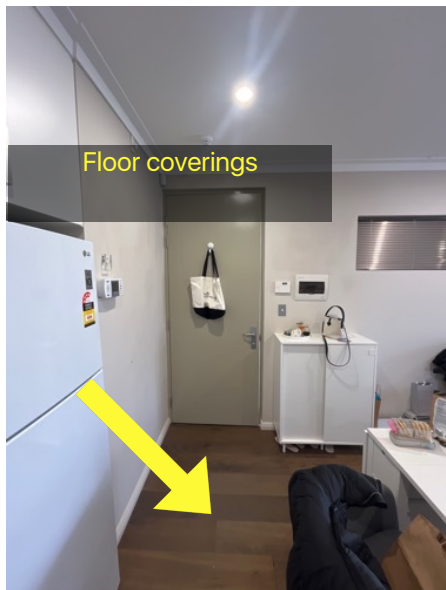
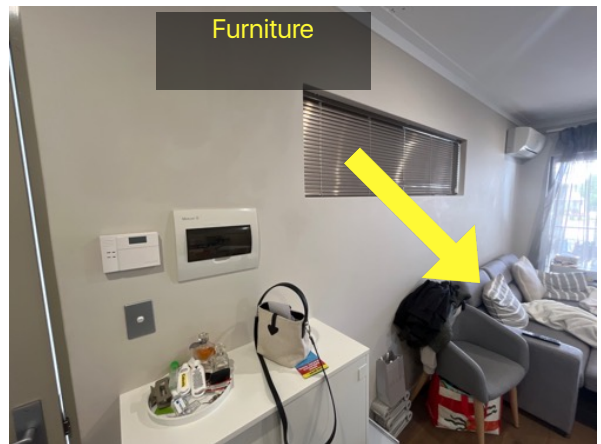
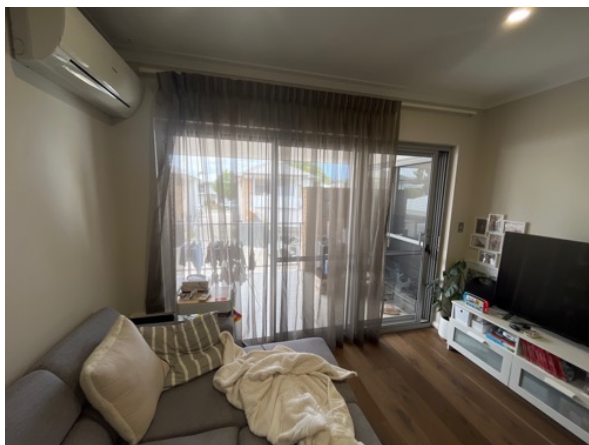
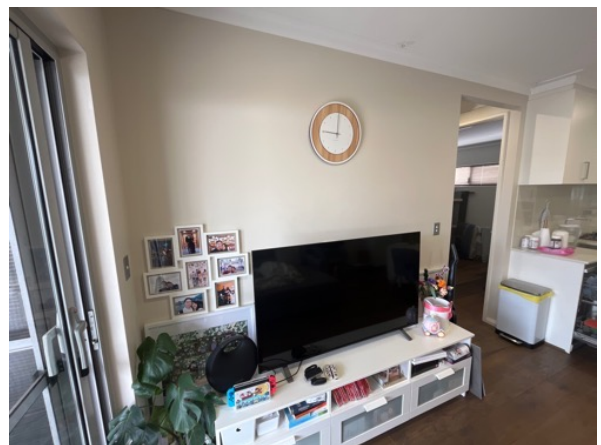
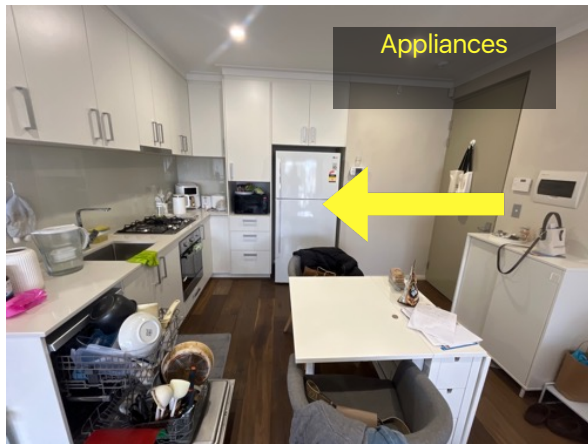
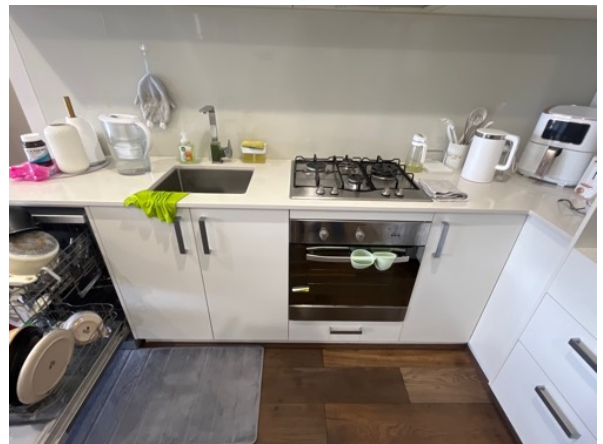
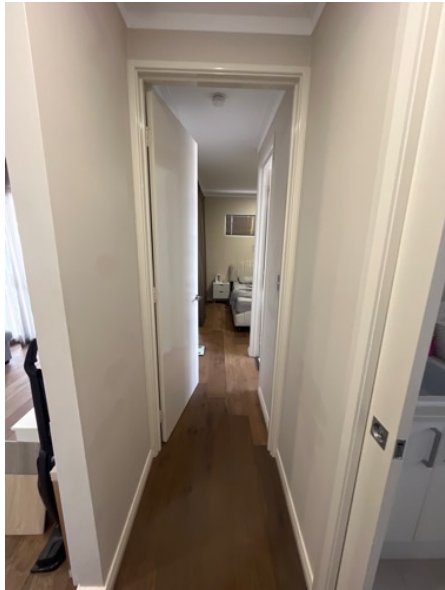
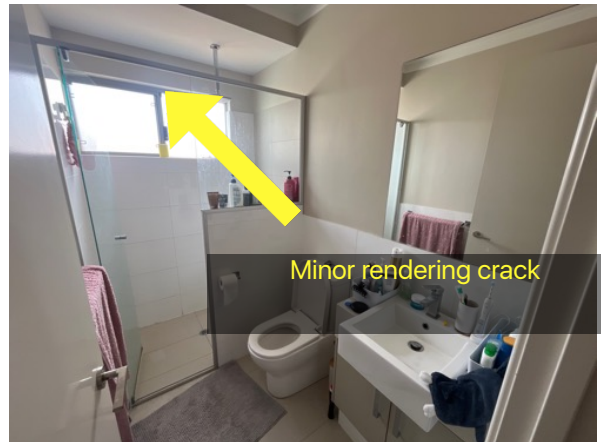
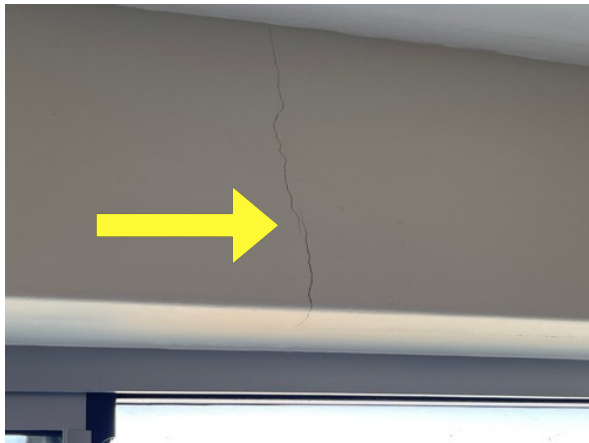
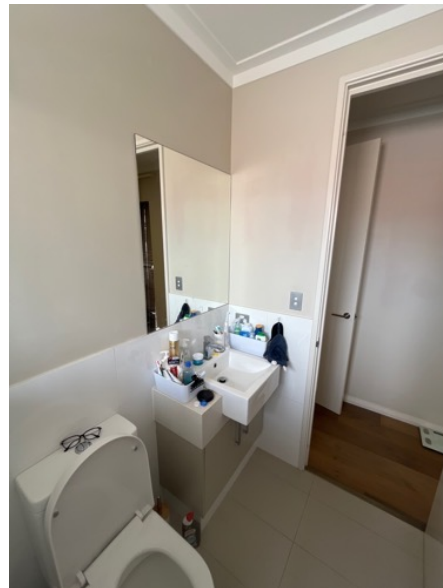
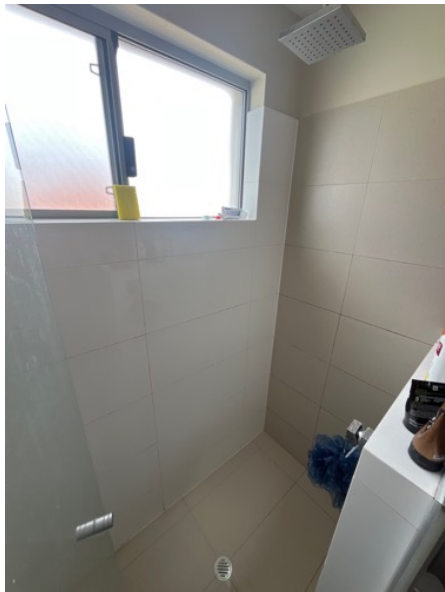
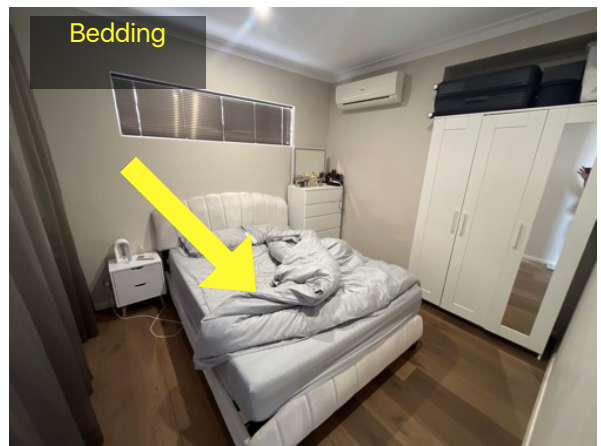
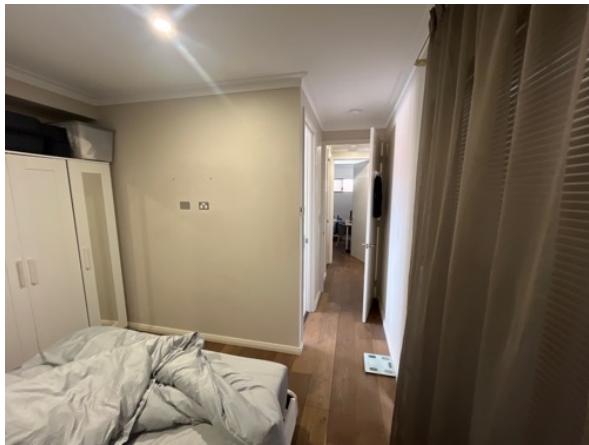
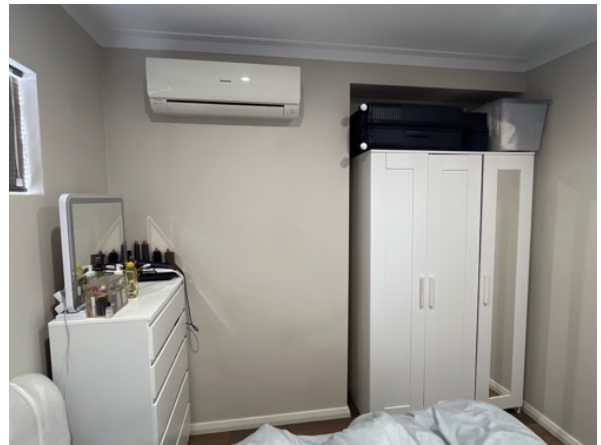
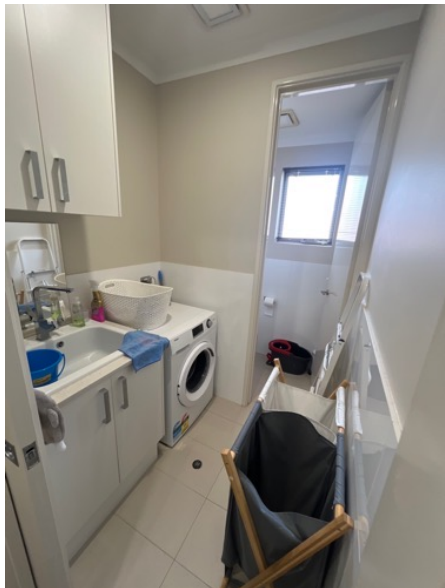
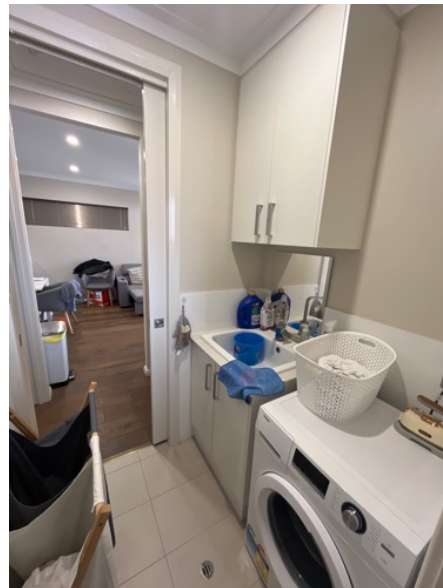
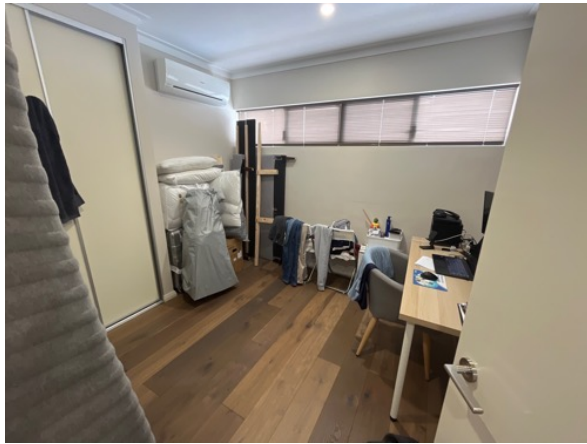
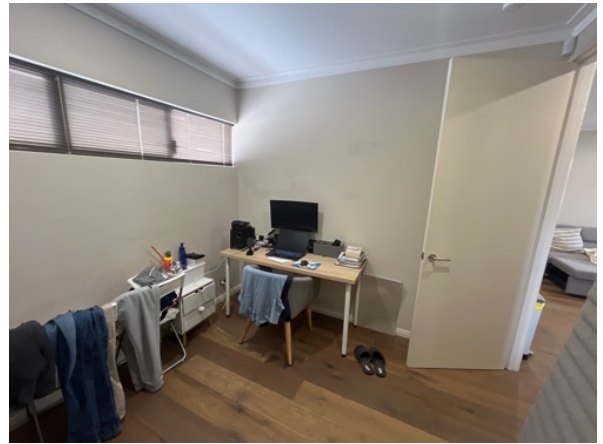
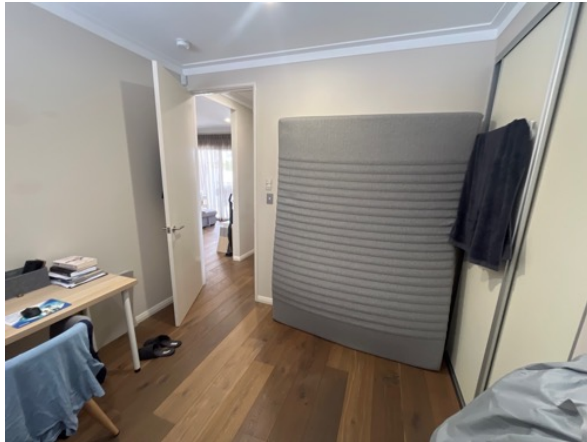
## For your information 1.04

**Location:** All Internal Areas

**Finding:** Additional Photos - Internal areas inspected

These photographs are an indication of the areas inspected. Some photographs may point out obstructions and limitations which impeded full inspection of the property at the time of inspection. Some photographs may also point out minor cosmetic maintenance items which are normally excluded from a structural inspection. Always contact your building inspector should you have any questions.

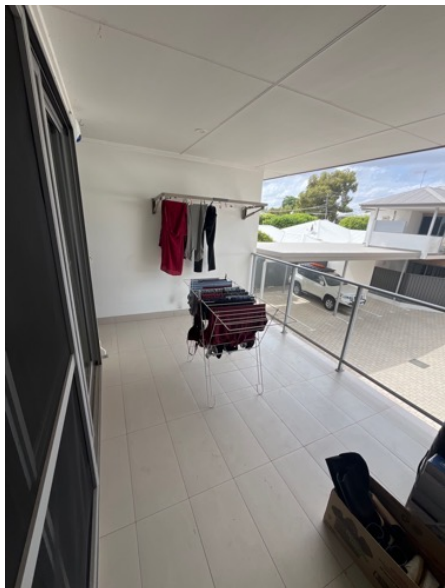
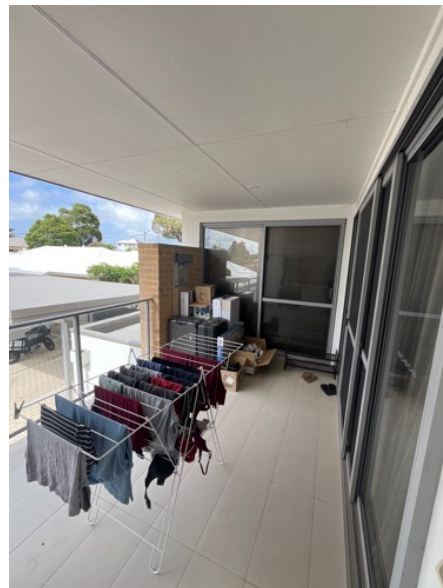
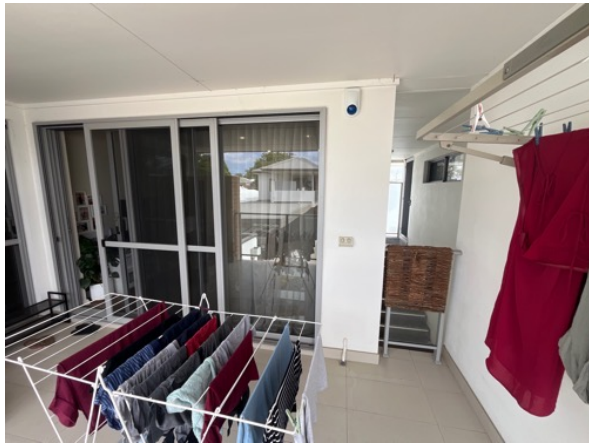
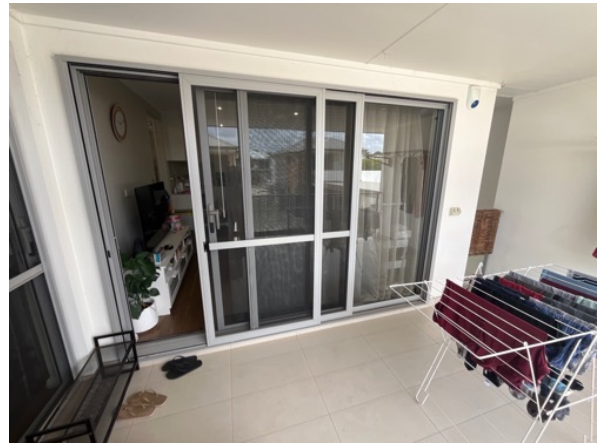
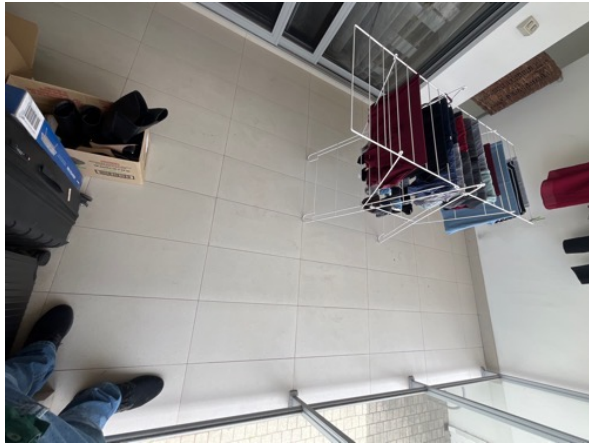
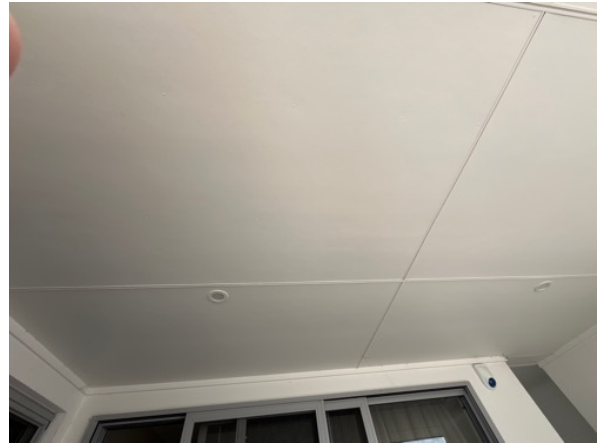
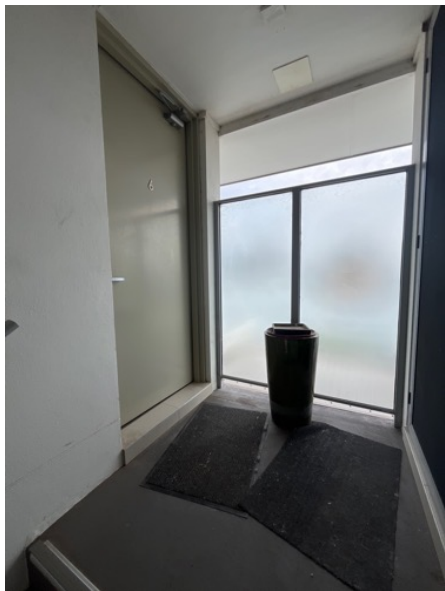
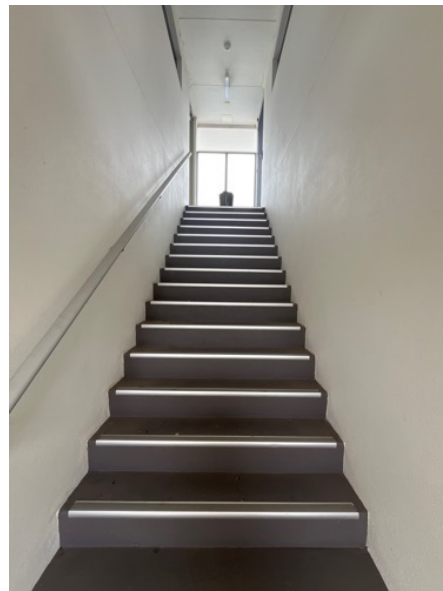
## For your information 1.05

**Location:** All External Areas

**Finding:** Additional Photos - External areas inspected

These photographs are an indication of the areas inspected. Some photographs may point out obstructions and limitations which impeded full inspection of the property at the time of inspection. Some photographs may also point out minor cosmetic maintenance items which are normally excluded from a structural inspection. Always contact your building inspector should you have any questions.
